## **Kansas City Downtown Streetcar Transit System Condition and Load Rating Assessment of Structures**

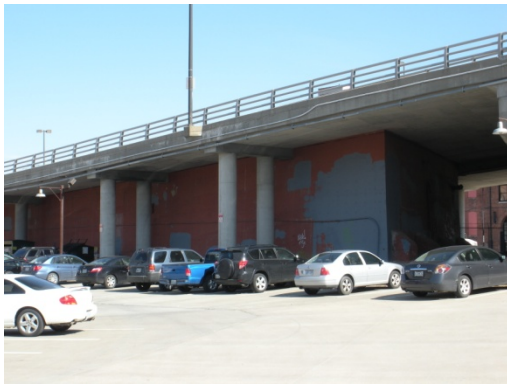
Below are photos of the Unit 1 voided slab spans. The voided slabs appear in good condition with very little deterioration shown. Some spalling and corrosion was noted on a few substructure elements in the voided slab spans under the expansion joints. However, there was nothing found that would affect the load rating capacity.

West Face of Voided Slab Spans

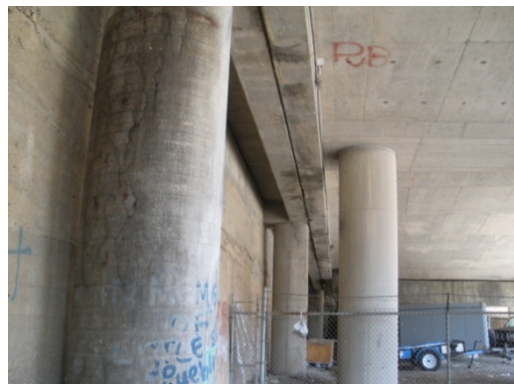
East Column of Bent 2N

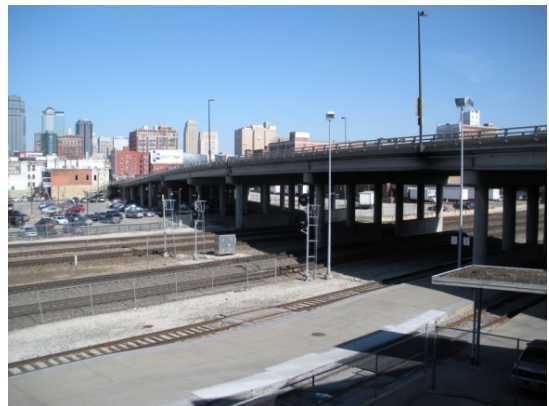
Units 2 – 5 are prestressed concrete girders and all elements of the superstructure and substructure were in very good condition. No significant issues were noted.

West Face of Prestressed Girder Spans

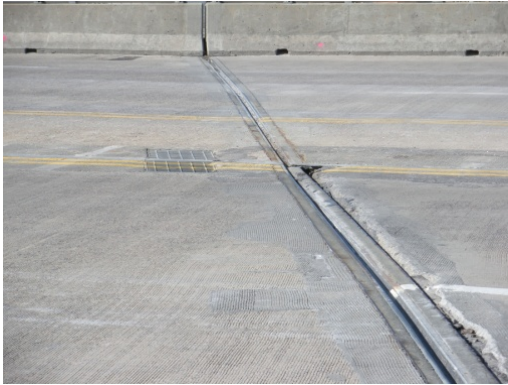
Strip Seal Joint

Repair work will be needed to the expansion joints. Some of the strip seal joints have large spalls behind the armoring and have become loose. We expect these can be patched and repaired. A good, durable detail will be required for the streetcar rails passing over these joints.

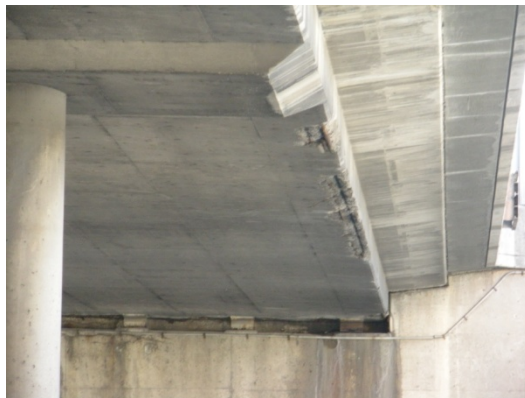
Spalls along West Face

The majority of the voided slabs appear in very good condition. There are numerous spalls and exposed reinforcing steel along the west edge of the slab. However, there is no water saturation or staining visible under the deck. The epoxy overlay is in excellent condition.

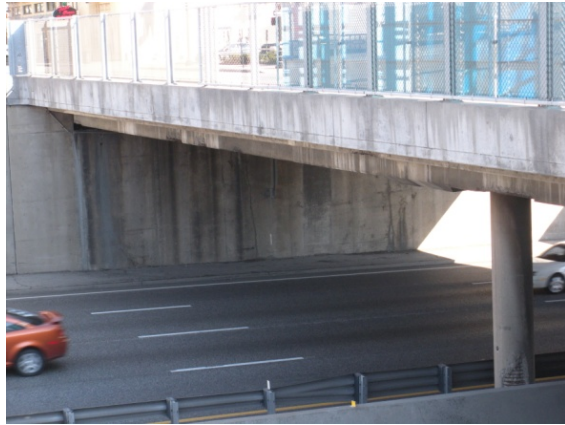
There is significant spalling and exposed reinforcing steel on all of the columns at the intermediate bent. Under most of the bearings at the abutments there is cracking and corrosion staining. There are also some large spalls in the abutment walls.

West Face of Bridge

The substructure deterioration does not currently affect the load rating capacity of the bridge. However, in the future significant substructure rehabilitation will be required to keep the bridge in service.

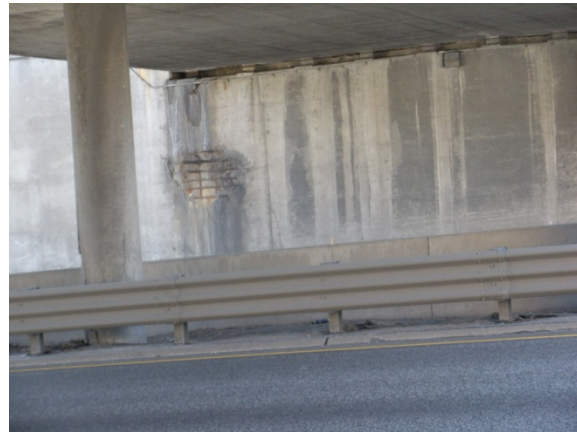
Large Spall in South Abutment

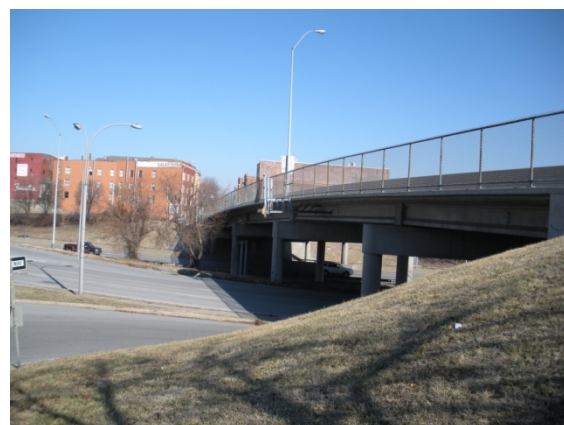
We believe the condition ratings above are appropriate. Some minor deck cracking was noticed, especially near the south end bent, but overall the concrete deck is in good condition. The prestressed girders and substructure elements are also in good condition.

West Face of Bridge

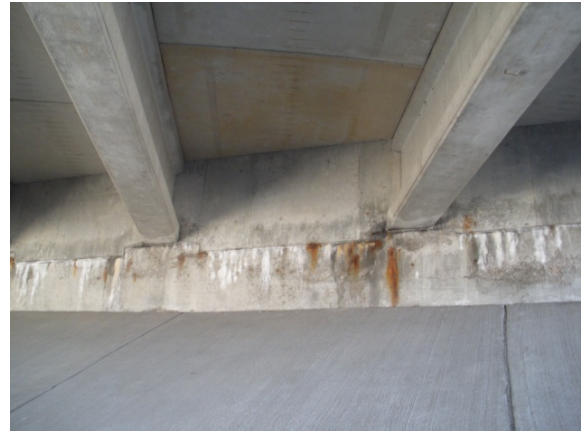
the south end bent water is getting behind the abutment and significant staining of the concrete is occurring on the front face of the diaphragm and bent cap.

South End Bent

We recommend replacement of the bridge approach slabs and repairs be made to the embankment behind the abutment and wings. The approach slabs need to be dowelled into the end bents to prevent the joints from separating.

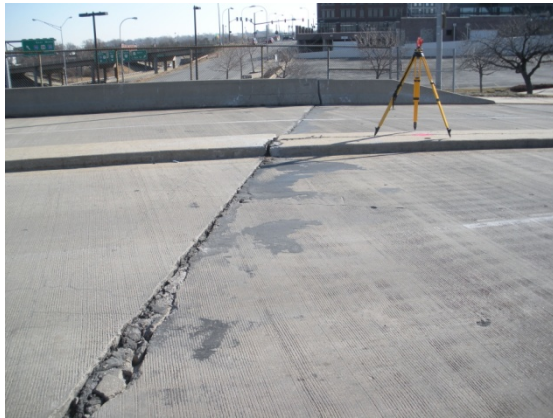
The only significant issue we found was the settlement of the approach slabs and deterioration of the joint between the end bents and the approach slabs. The approach slab joints at the bridge have been a constant maintenance item. Significant settlement has occurred under the approach slabs and the sidewalks. At

The bridge is fairly long with integral abutments and a 24 degree skew. The temperature movement combined with the skewed abutments may be contributing to the settlement and deterioration of the approach slab joints. These joints need to be stabilized for the streetcar rails.

Approach Slab Joint at South End Bent

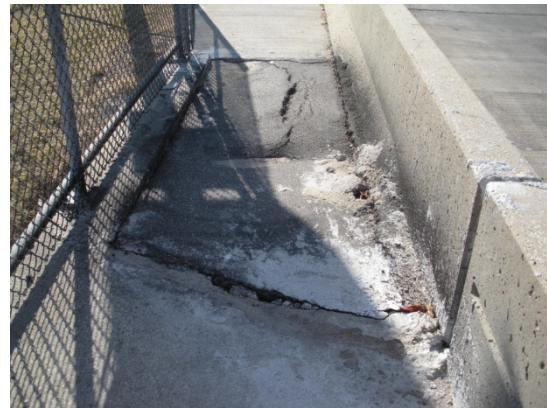
Settlement of Sidewalks at Approach Slab
